Blue River Home Inspections and services, Inc.

Inspection report

SUBJECT PROPERTY xxxxxx, Summit County, CO

DATE: April 2, 2013

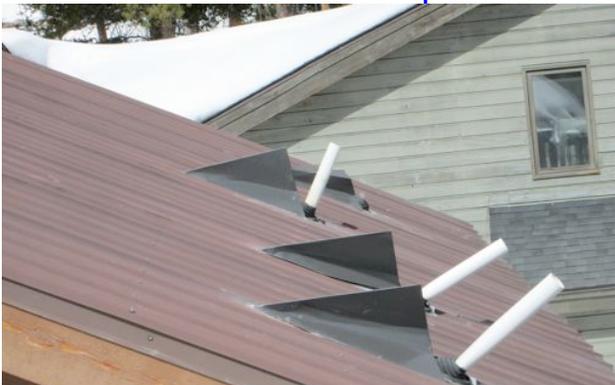
1.0 Two broken plumbing stacks are visible on the north facing sheet metal roof slope.

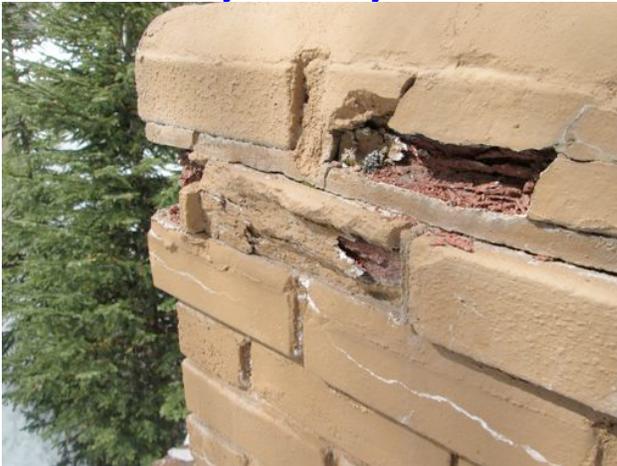
1.2 The top courses of bricks have deteriorated substantially on the masonry chimney. These should be repaired.

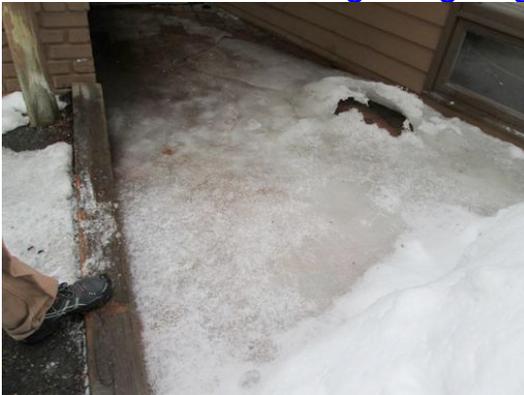
2.0 Poor drainage is allowing water from melting snow to drain toward the house and garage. Ice has built up in the front porch and is infiltrating the garage under the garage door.

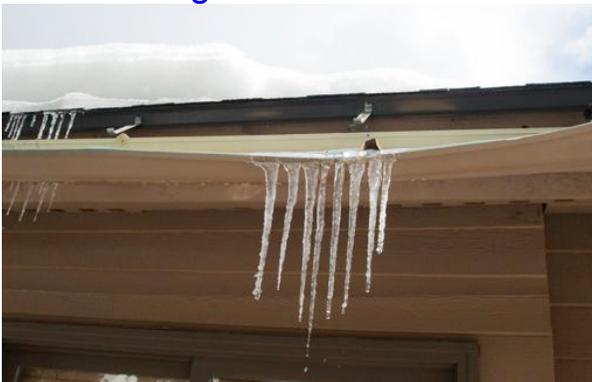
2.1 Rain gutters are damaged from excessive ice buildup and are overflowing. I recommend having the gutters replaced where damaged.

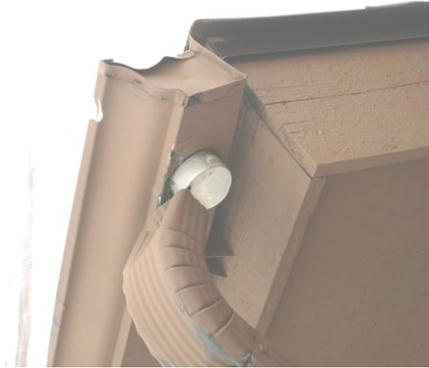
2.4 The gutters and downspouts are disconnected on the north side of the house.

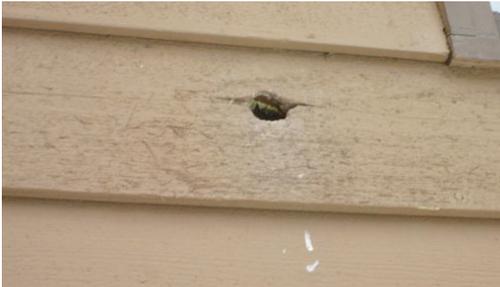
2.5 Bird holes are visible in the north and east exterior walls. I recommend having them repaired before birds return for the summer.

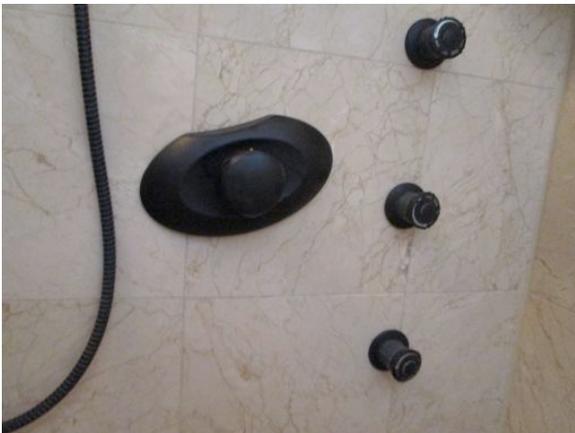
7.0 The water control flange is loose at the wall in the shower stall in the master bathroom.

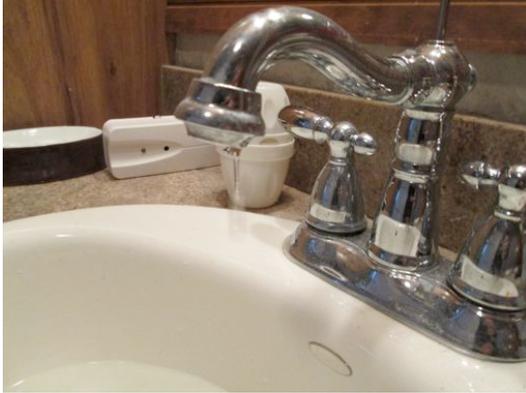
- 7.1 The toilet is loose at the floor in the lower bathroom.
- 7.2 A slow drip leak is visible from sink spout in the lower bathroom. The hot water faucet does not turn off completely. The hot water is turned off at the isolating valve under the sink

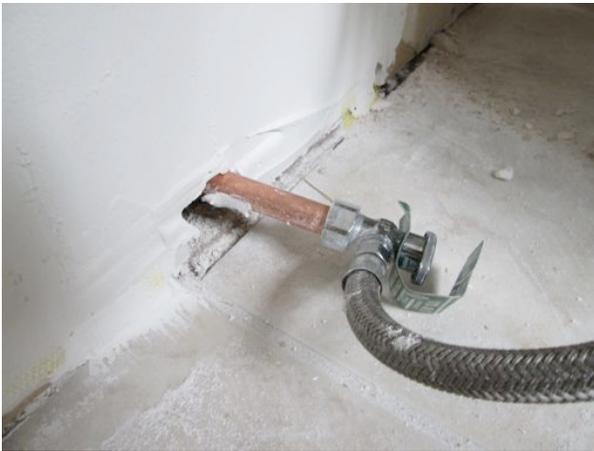
- 7.3 The water supply pipe is loose at the wall at the toilet in the mid level master bathroom.

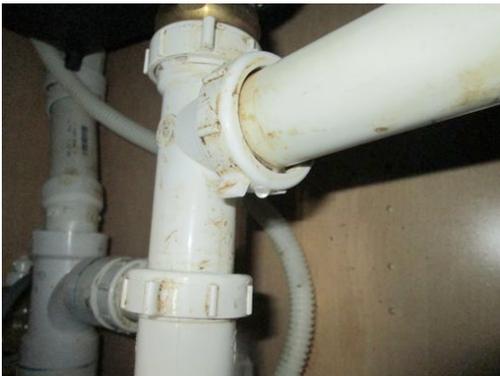
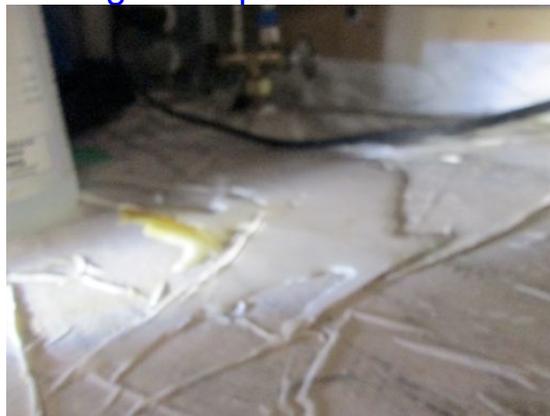
- 7.4 Water leaks from the drainpipe connection under the left sink in the kitchen. I recommend having this repaired.

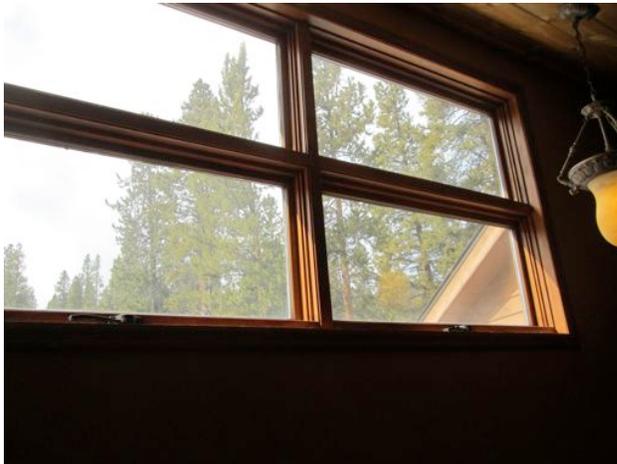
9.0 Condensation residue is visible between the panes in the upper
left fixed window on the south wall of the loft area.

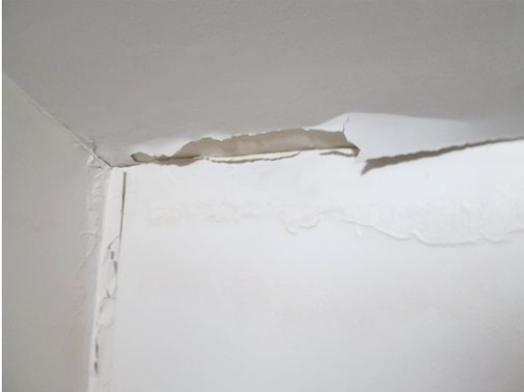
9.1 Minor water damage is visible on the wall of the closet in the upper guest bedroom.

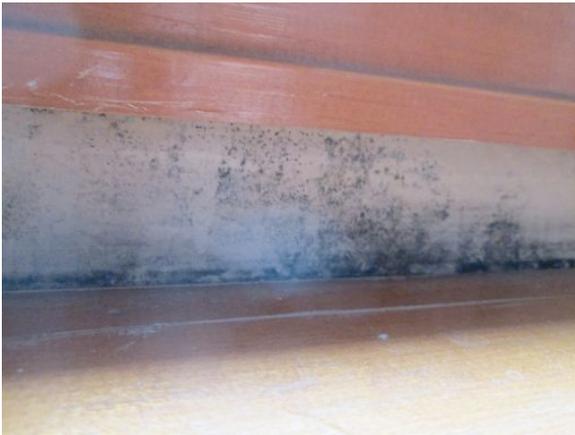
9.2 Black moisture spots are visible under the window in the lower bathroom.

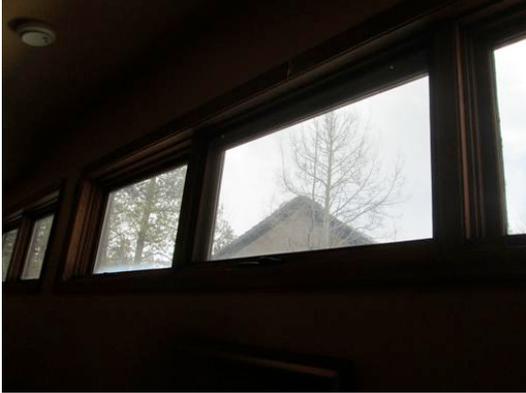
- 9.9 The closet window will not open in the upper master bathroom.
9.20 The sliding window is stuck closed in the lower bathroom.
9.21 Condensation residue is visible between the panes in the middle awning window in the upper guest bedroom.

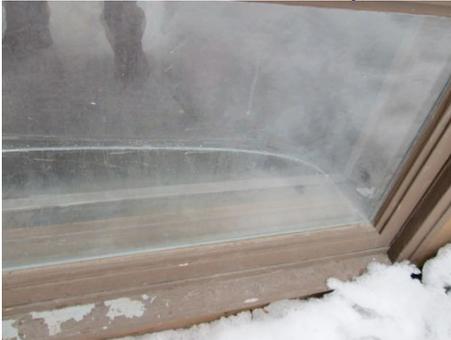
- 9.22 None of the awning windows in the mid level sun lounge open.
9.23 I was unable to turn on the fireplace and light the pilot light at the fireplace in the sun lounge.
9.24 Broken windowpanes are visible in the garage and sun lounge.

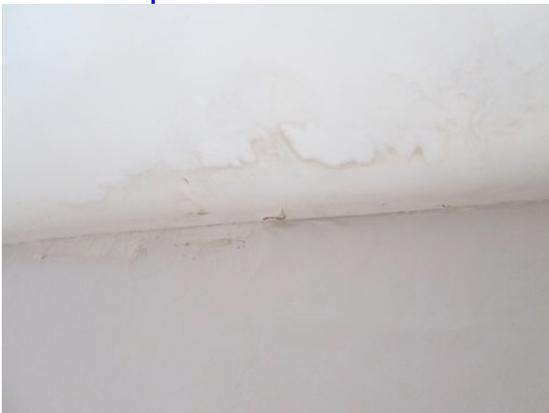
- 9.25 Minor water damage is visible on the wall/ceiling behind the fireplace in the main level.

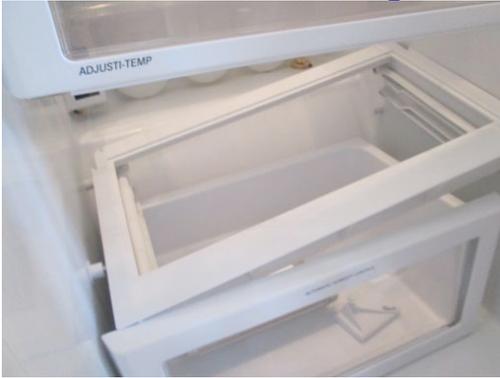
10.0 The door shelves are missing and damaged in the main refrigerator.

10.1 The bottom shelf glass is missing in the main refrigerator.

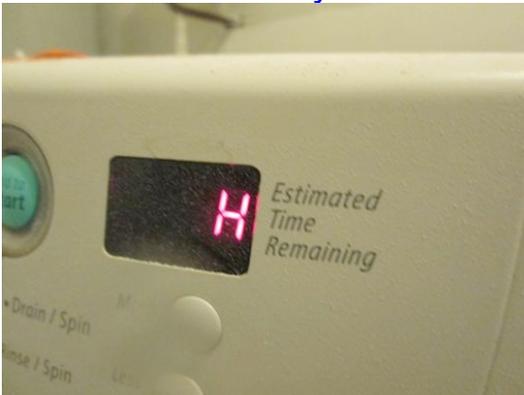
10.2 Water leaks from the hot water hose connection in the lower laundry room.

10.3 The washer did not complete the wash cycle, H indicator appeared on the digital read out. The test was abandoned. Lower laundry room.

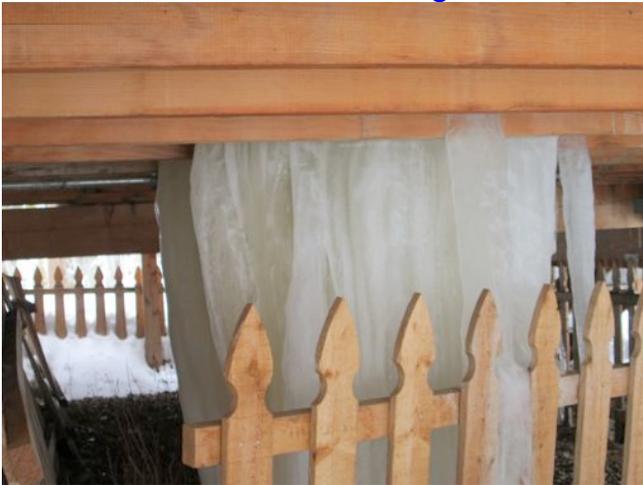
11.0 The hot tub is leaking under the tub.
