Blue River Home Inspections and services, Inc.

Inspection report

SUBJECT PROPERTY xxxxxx, Summit County, CO

DATE: April 2, 2013

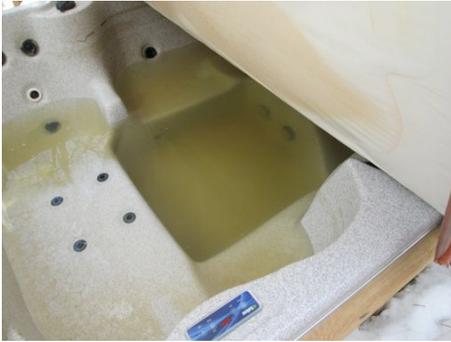
The Hot tub was not tested or inspected due to low and dirty water.

11.0 The hot tub is leaking under the tub.
